Benthic Video Monitoring in the Providence River Estuary – What do we see?

Eliza C. Moore, M.S.
Narragansett Bay Commission

NEERS – April 27, 2018
Portsmouth, NH

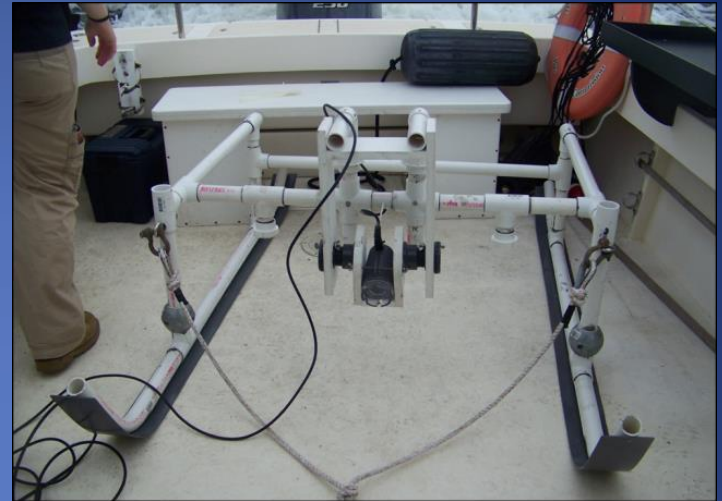
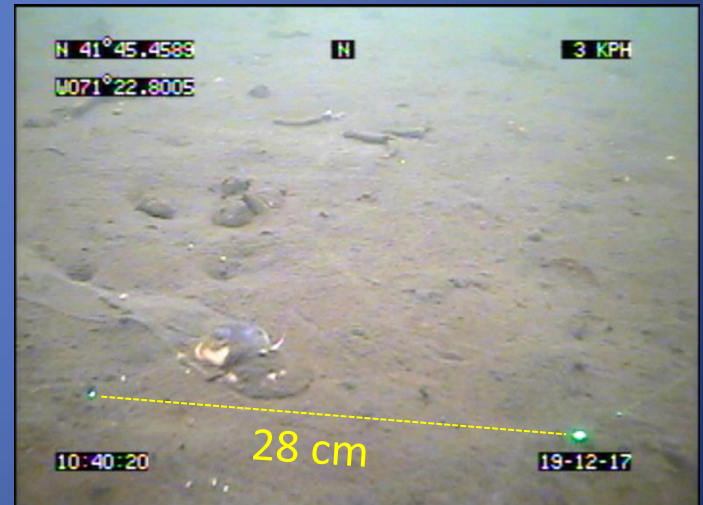
- Began in October 2014
- Focus on three transect areas
 - 1-5 m depth
- SeaView camera
 - Scale lasers added 2017

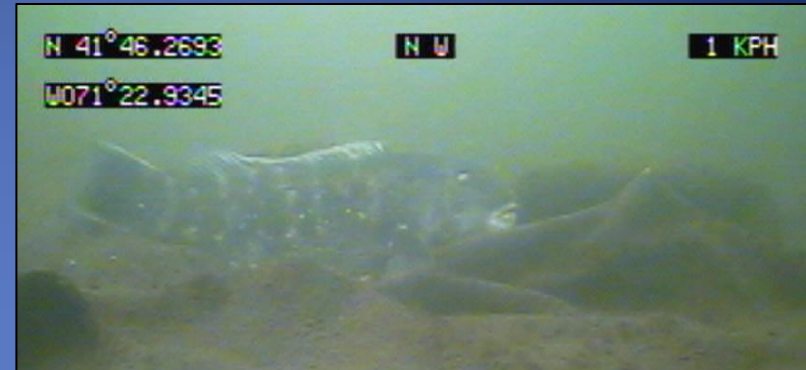
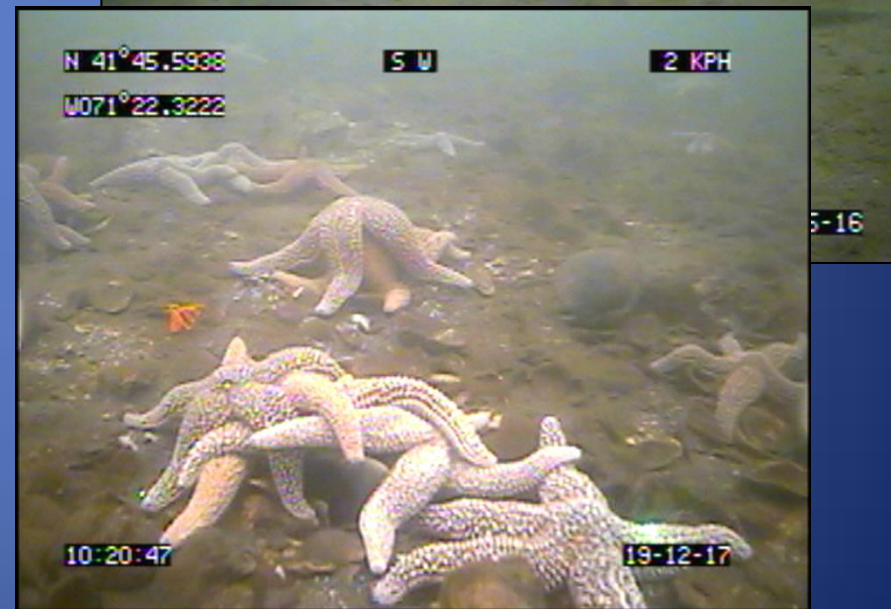
- Video subsampled every 5 minutes
 - CMECS (substrate and dominant biota)
 - Single frame
 - Counts
 - 60 sec.
- Rare observations (whole video)

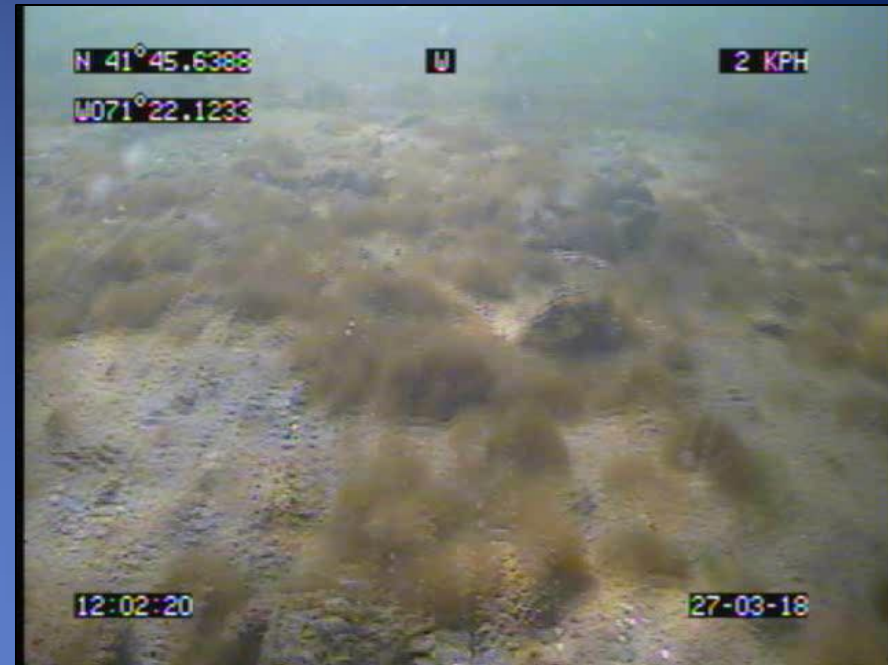
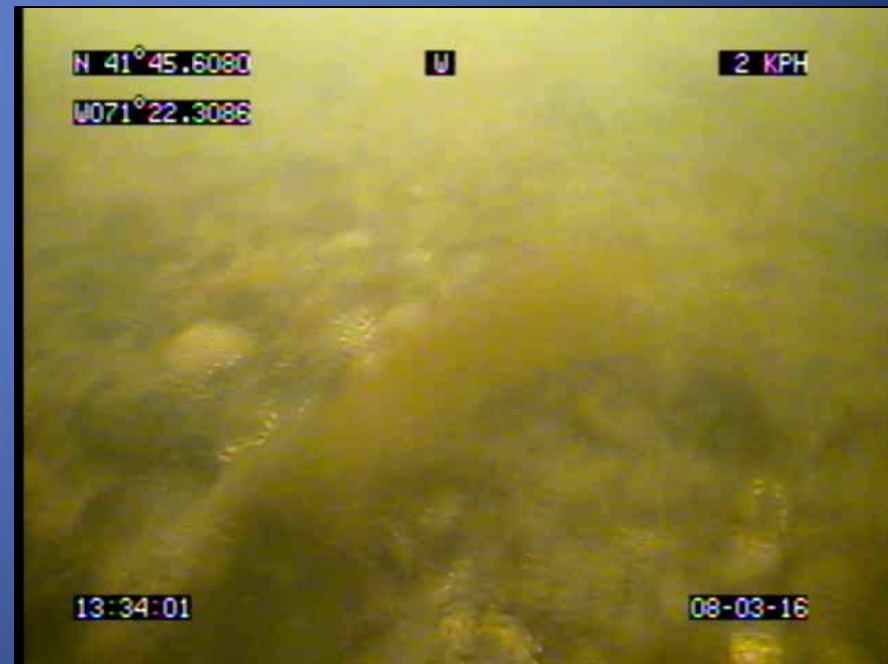
- Bushy brown alga or colonial diatoms
 - Late winter (March)
 - Mostly at Sabin

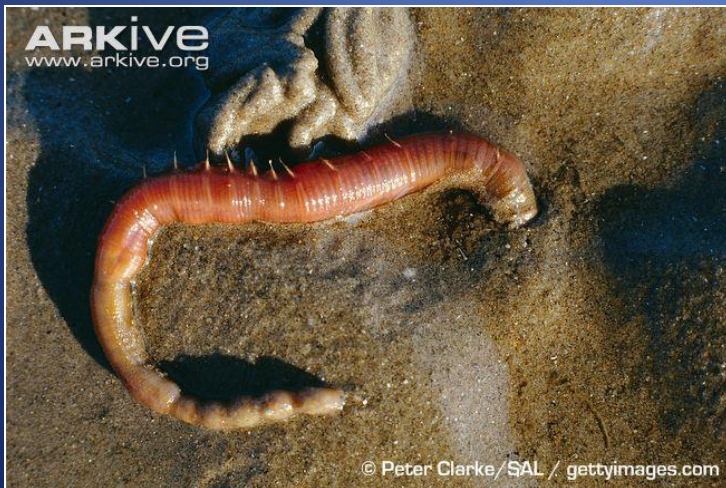
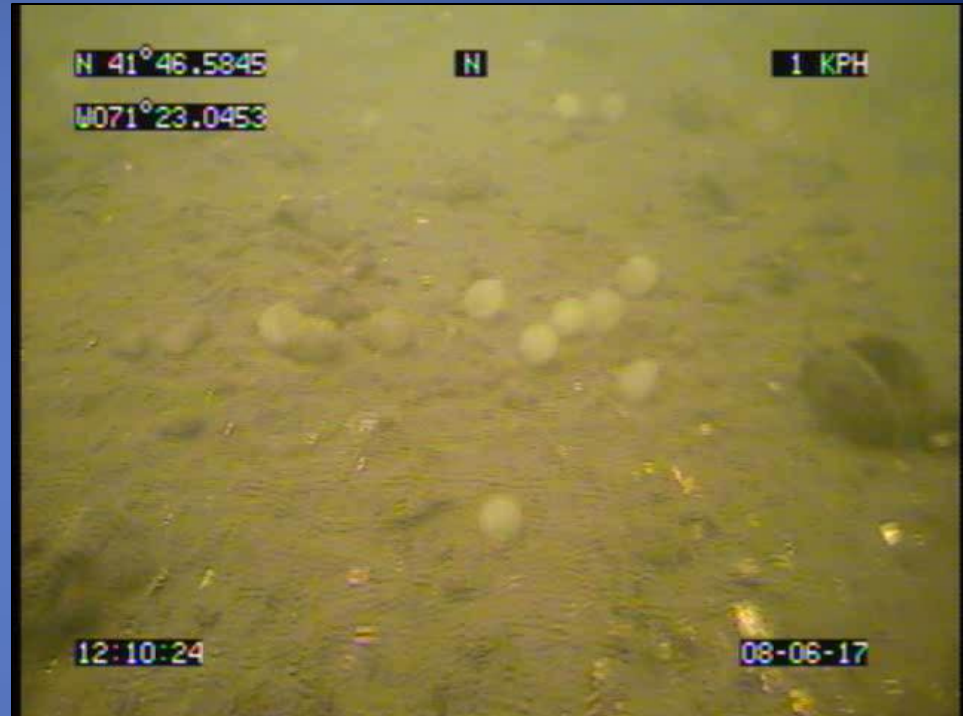
- Lugworm (*Arenicola cristata*) egg sacs
 - May-July
 - Most abundant at Edgewood, but seen elsewhere.

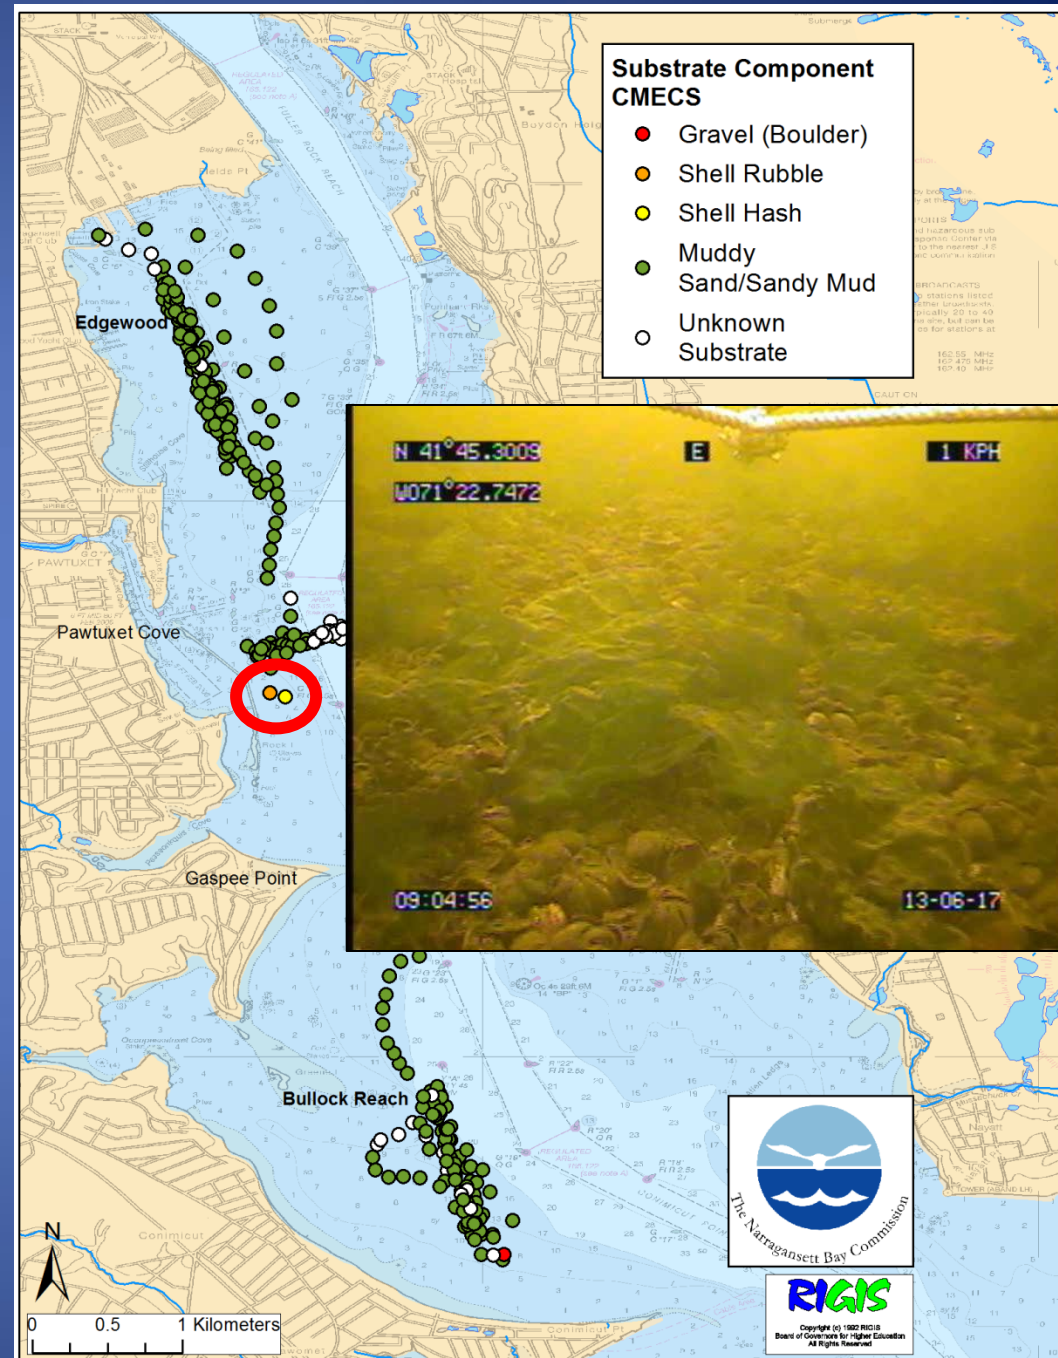
- Dominant Substrate Type
 - Fine (muddy sand, sandy mud)
 - Shell Hash/Rubble mainly off Sabin Point
 - Sporadic areas of boulders/large cobble
 - *Crepidula* reef

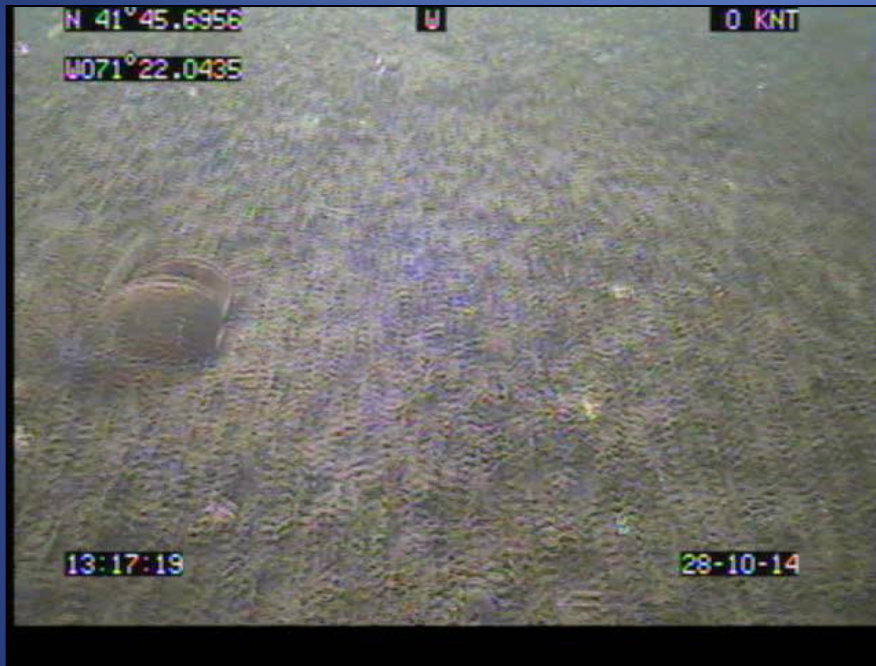
- Amphipod tube mats

- High organic matter
- Expect a decline with nutrient reduction?

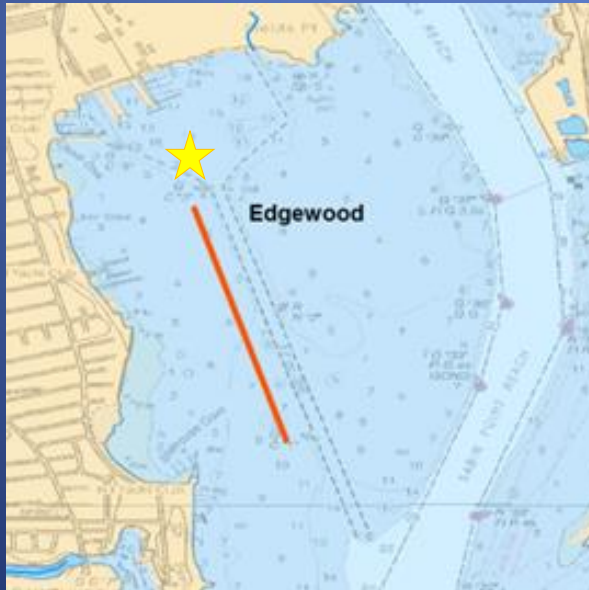
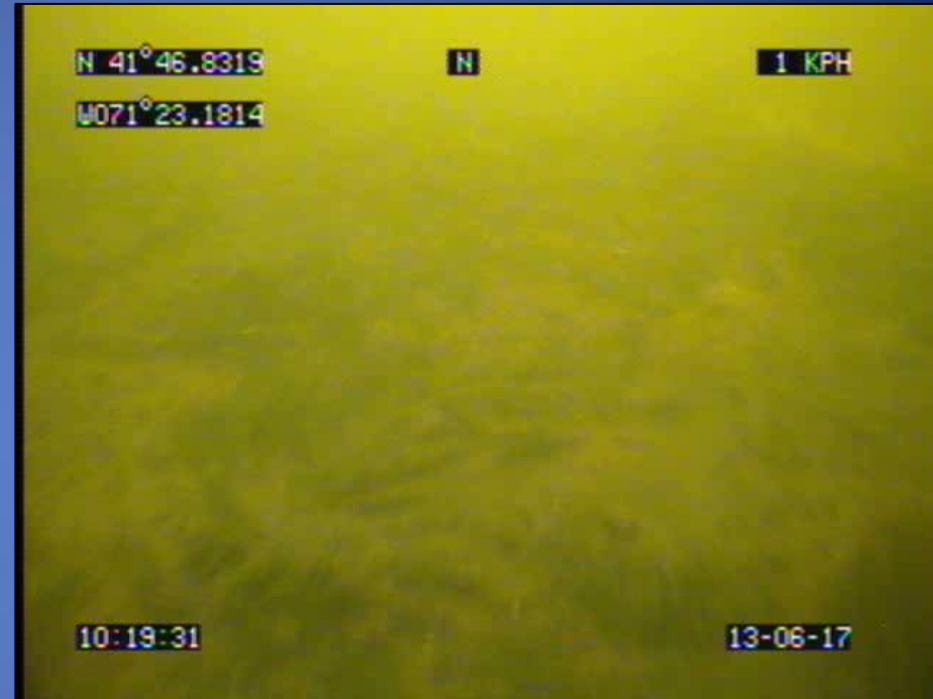
Video from June 13, 2017

- *Beggiatoa*
 - Bacterial growth indicative of hypoxic/anoxic conditions in turning basin
